## DETERMINATION OF LIVING ORGANISMS ON STONE WALLS OF THE ARCHITECTURAL HERITAGE BUILDINGS IN SOUTHERN HERZEGOVINA (STOLAC, POČITELJ, HUTOVO)

*Original scientific paper*

Nermina Mujezinovic<sup>1</sup>, Irma Mahmuljin<sup>2</sup>

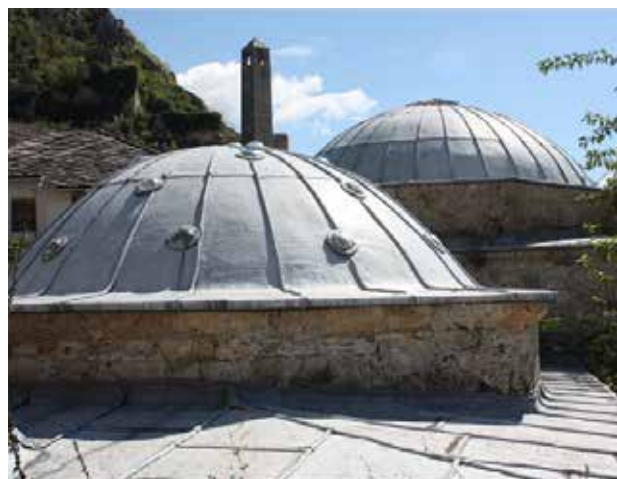
**Figure 1:** Hammam (Turkish bath) in Počitelj

Similar biocommunities were found on the wall surrounding the hammam in Počitelj although biocolonization of stone walls by lichen here is much less represented here compared to the megalithic wall in Ošanići. The growth of plants in the stone cavities, however, is more intensive here. Some sections of the wall evidently retain water and dry harder, and it is in these areas that we detected greenish film on the stone blocks. There is also a sporadic presence of white and yellowish stains affecting a small surface area of the wall.

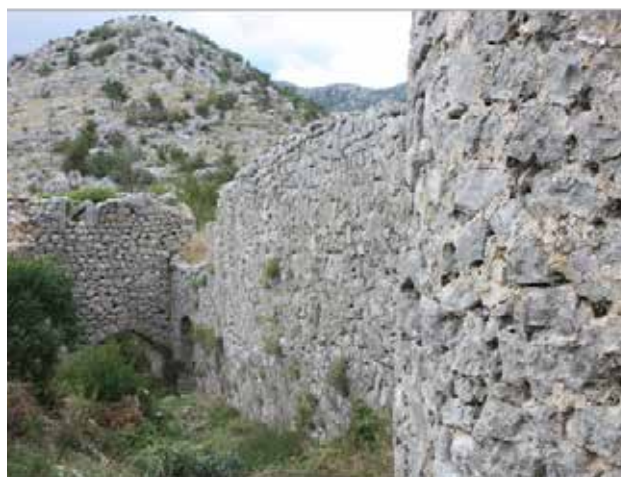
**Figure 2:** Hutovo old town, detail

The wall surrounding the Hutovo fort is built of partly-dressed stone blocks, more regular in shape, and laminated stones without any binding material. Looking at the entire surface area of the wall, the texture is not homogeneous and surface roughness varies both quantitatively (degree of roughness) and qualitatively (profile and morphology). Sporadically, it is very rough mostly as a result of erosion, differential erosion and other types of deterioration, and some stone blocks are visibly patchy due to the loss of material.

The characteristic manifestation of colonization of the wall in front of the Hutovo fort is mostly pigmentation, that is, the presence of white, black and brownish stains on stone blocks. There are no moist areas on the observed surface area or areas with greenish or blue-green biofilm.

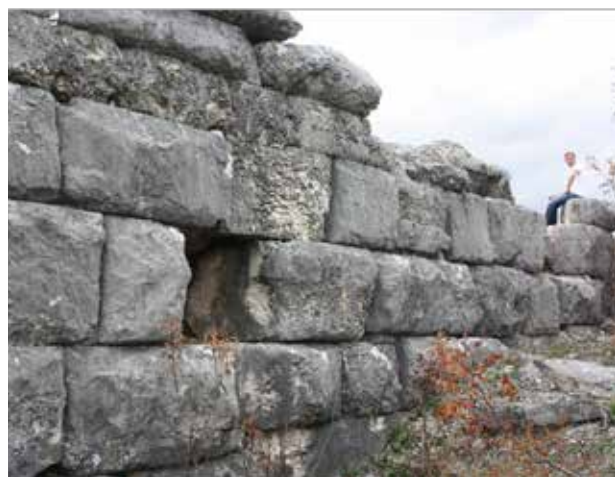
**Figure 3:** Hillfort in Ošanići near Stolac – Megalithic wall

General condition of the megalithic stone blocks in Ošanići hillfort is not homogenous either quantitatively or qualitatively (this also applies to biological degradation). From one segment to the other, the number, order and position of blocks vary in terms of characteristic pathology, or some type of deterioration of stone material. Almost all types of deterioration are present more or less: discoloration and deposit, detachment, material loss, dislocation, cracks, completely destroyed missing elements and parts. Deterioration caused by anthropogenic factors reflected here in the consequences of previous restoration efforts is a separate deterioration category. (Figure 1, Figure 2).<sup>19</sup>

Biological colonization is most prominent on the north-east facade and on the top of the megalithic wall. Lichen dominate, along with the algal growth while moss is very rarely observed. There is a diffused pigmentation on the stone blocks in the form of white, black and colored stains, and on some surfaces in the wall's interior, visibly moist, we sporadically came across blue-green film. The orientation numerical data about the colonization of the facade by microorganisms and vegetation relating to the condition of stone walls in 2010 is quite illustrative.

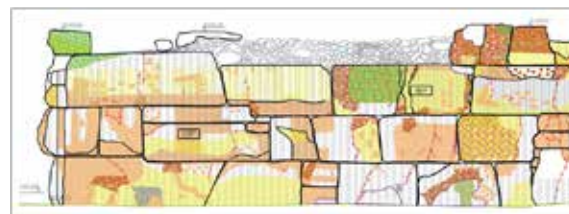
Figure 4

**Figure 4 i 5:** Mapping of deterioration with classification of different types, megalithic wall in Ošanići, 2009, prior recording of stone structures was done by a laser scanner. From: Mujezinović, N. 2010. Determination of deterioration patterns and the condition of megalithic wall with the towers; Hellenistic urban complex at Gradina (Hillfort) in Ošanići near Stolac, study on conservation and protection of the archaeological site. Sarajevo: National Museum of Bosnia and Herzegovina.

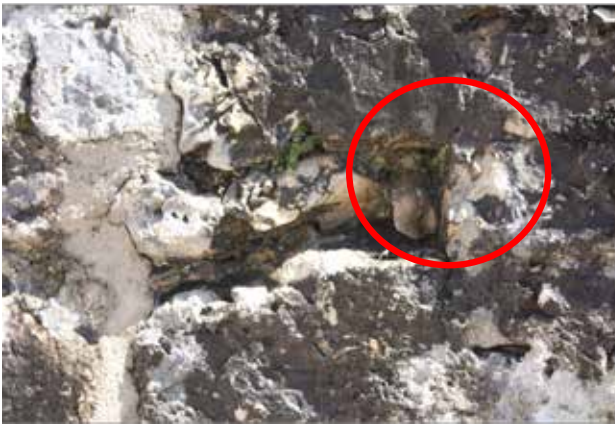
**Figure 6.** Sampling position “I”, Počitelj, hammam

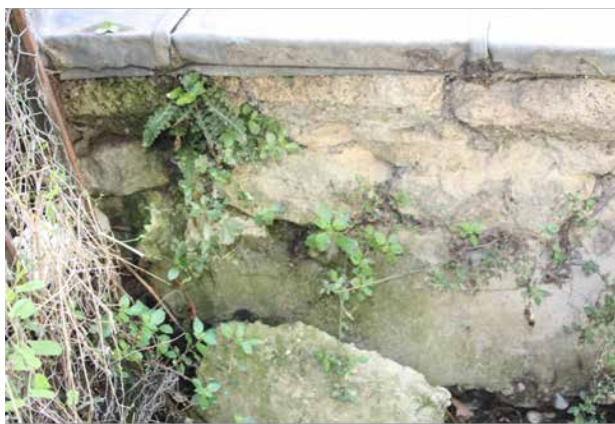
**Figure 8.** Sampling position “VII”, Počitelj, hammam

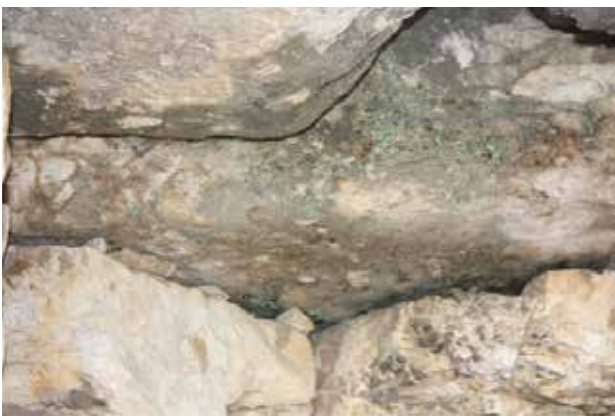
| LOCATION | TYPE | DESCRIPTION |
|---|---|---|
| OŠANIĆI VIII - green algae | <i>Gloeocapsa</i> sp. | Blue-green algae |

**Figure 9.** Sampling position “VIII”, Ošanići hillfort, megalithic wall

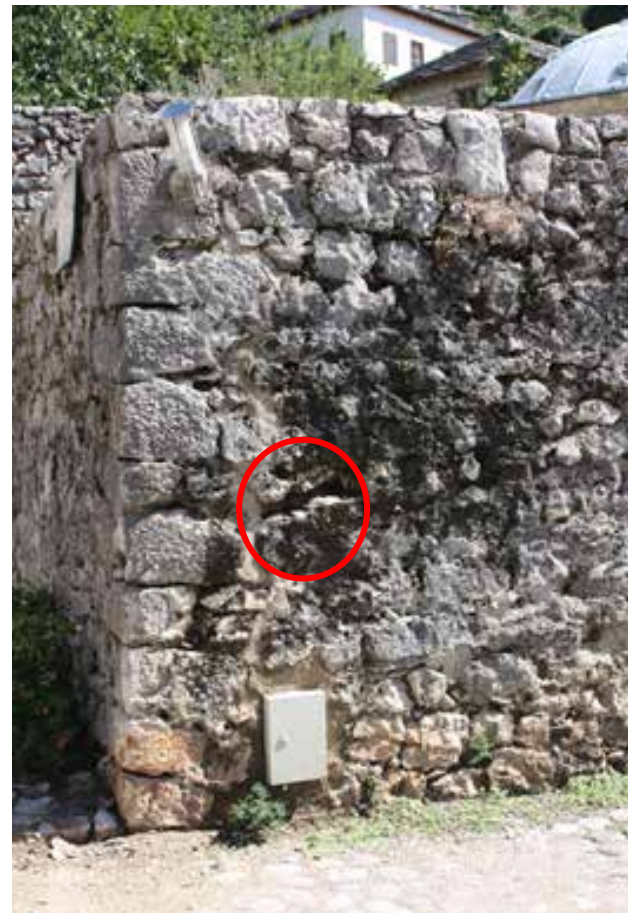
**Figure 7.** Sampling position “I”, Počitelj, hammam

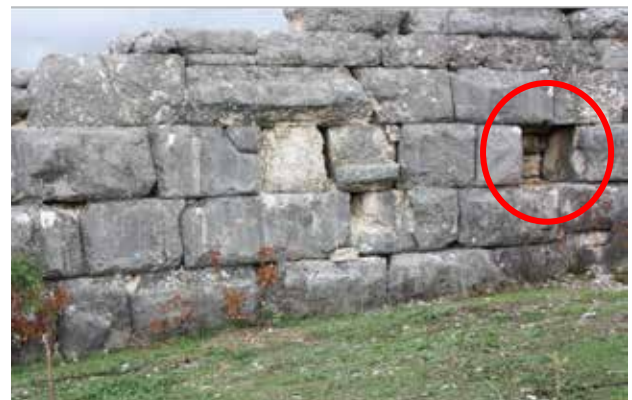
**Figure 10.** Sampling position “VIII”, Ošanići hillfort, megalithic wall
